# TODAY'S ENERGY AUDIT

A first-hand account of how audits can help homes.

BY BILL SPOHN, P.E.

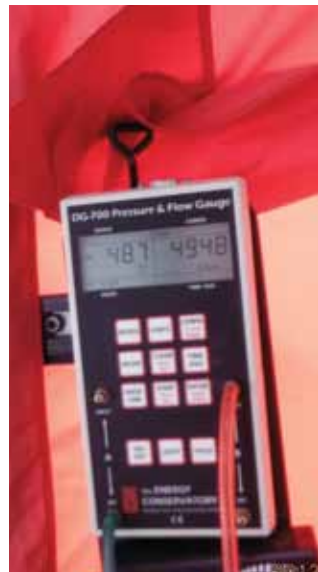
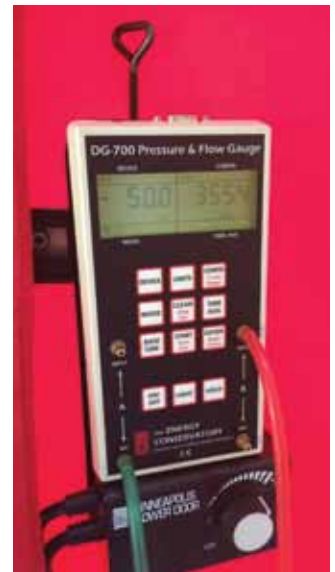
⚡ **Blower-door tests (in/out) place the house under a negative pressure to check for air tightness and enhance thermal imaging, all parts of a proper energy audit.**

Square footage, wall area and interior volume were determined and calculated, in our case from the house plans (built in 1989). These factors are used later when comparing the home performance to standards, norms, and before and after tests. Next, the home was set up—all air moving (such as the HVAC system and fans) and combustion appliances (such as domestic hot-water heaters) were disabled and all windows and doors closed. The house was placed under a negative pressure (50 Pascal or 0.2 in. wc) with a blower door to check for

air tightness and enhance thermal imaging. The auditor then walked systematically around the inside of the house (“always take right turns”) taking thermal and visual images of the walls that exhibited the most energy loss. Major calls this the blower door/thermal dance. Next, the blower-door test results were recorded and the HVAC system was fired up and air flow (supplies and returns) and static pressure was checked.

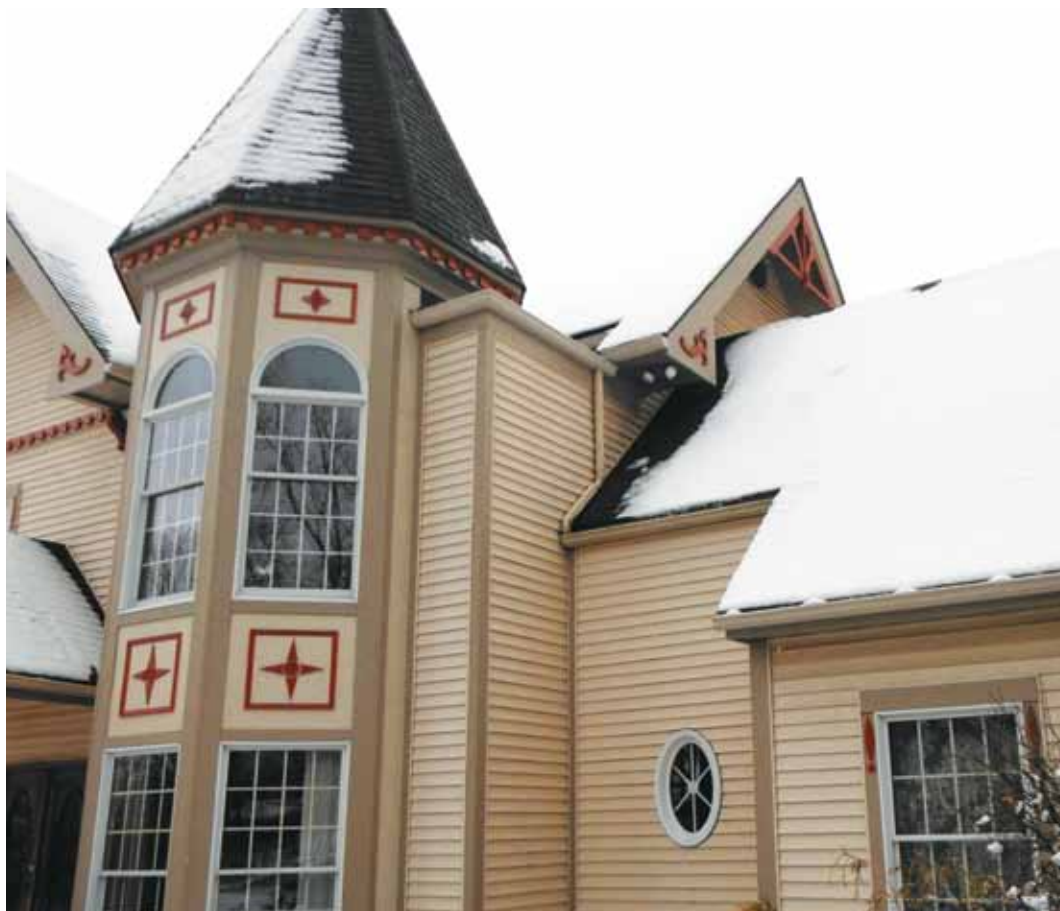
« During the energy audit, the inspector walked the perimeter of the property and noted things like gaps in the envelope and snow-melt patterns (seen here).

Our energy audit was performed by The Energy Doctor (Rhett Major) of Irwin, PA, on a cold day late in March. The first step was a walk around the house looking for exterior signs of energy loss (gaps in the envelope, snow-melt patterns, etc.) and building durability issues (such as water infiltration). The next step was a walk around the entire house, from basement to attic, paying special attention to pathways for air infiltration. Photo documentation is essential in remembering all the details (197 photos were taken during my audit).

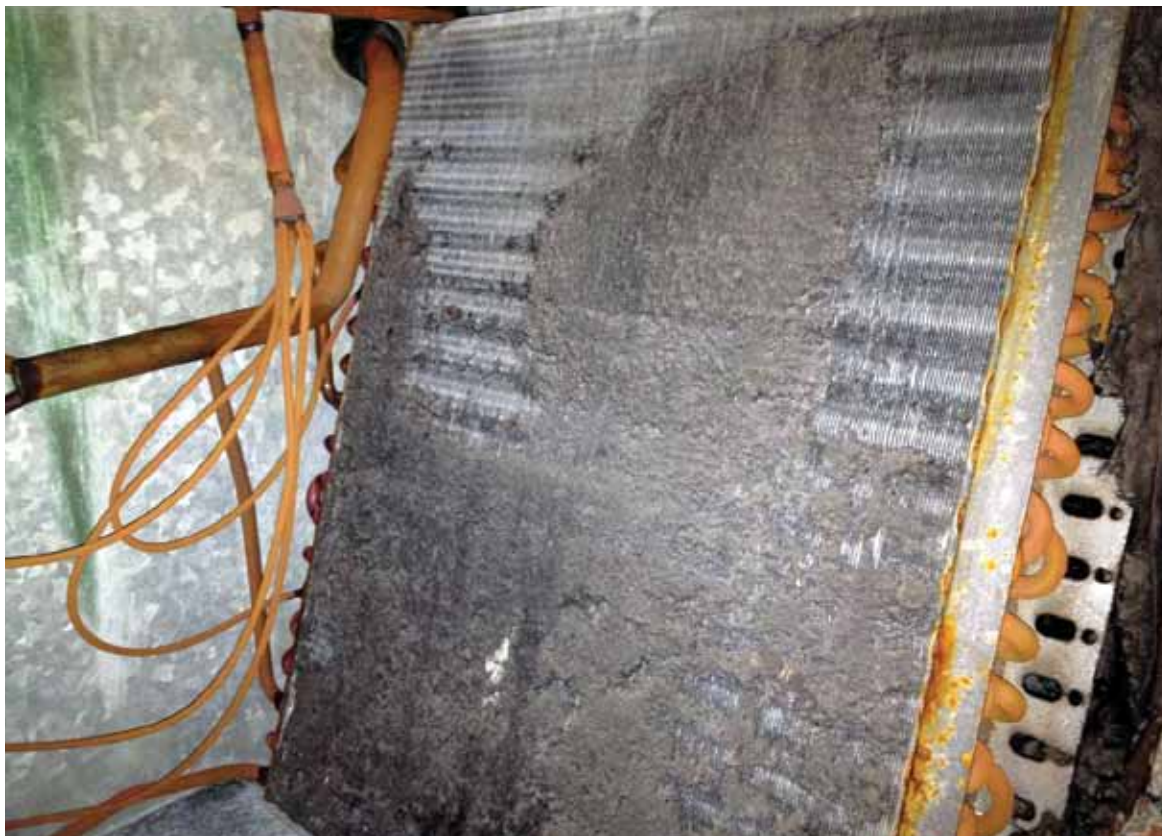
>> A dirty evaporator coil (shown here) is one of many reasons for a system to not run effectively or efficiently.

Additionally, the 24-year-old furnace had a blocked evaporator coil and lousy return air flow from most rooms. The decision was made to replace the HVAC system, as the cleanup and servicing would be costly. Plus, the (future) tighter home will produce less load and efficiency and comfort factors of HVAC systems have changed drastically in the last quarter century.

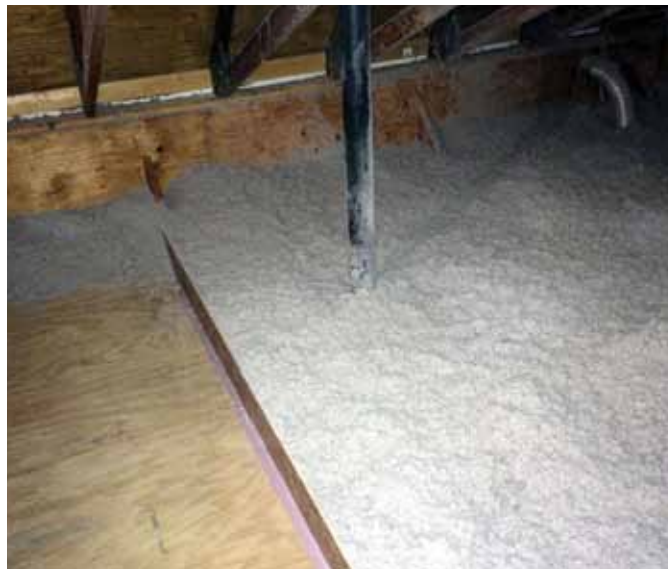
⤵ In addition to a new attic hatch cover being built, blown-in cellulose was added to increase effective attic deck R-value to about 49.

Additionally, a new attic hatch cover was built, which helped to eliminate the 10-Pascal connection between the attic and house, while the blown-in cellulose was added to increase effective attic deck R-value to about 49.

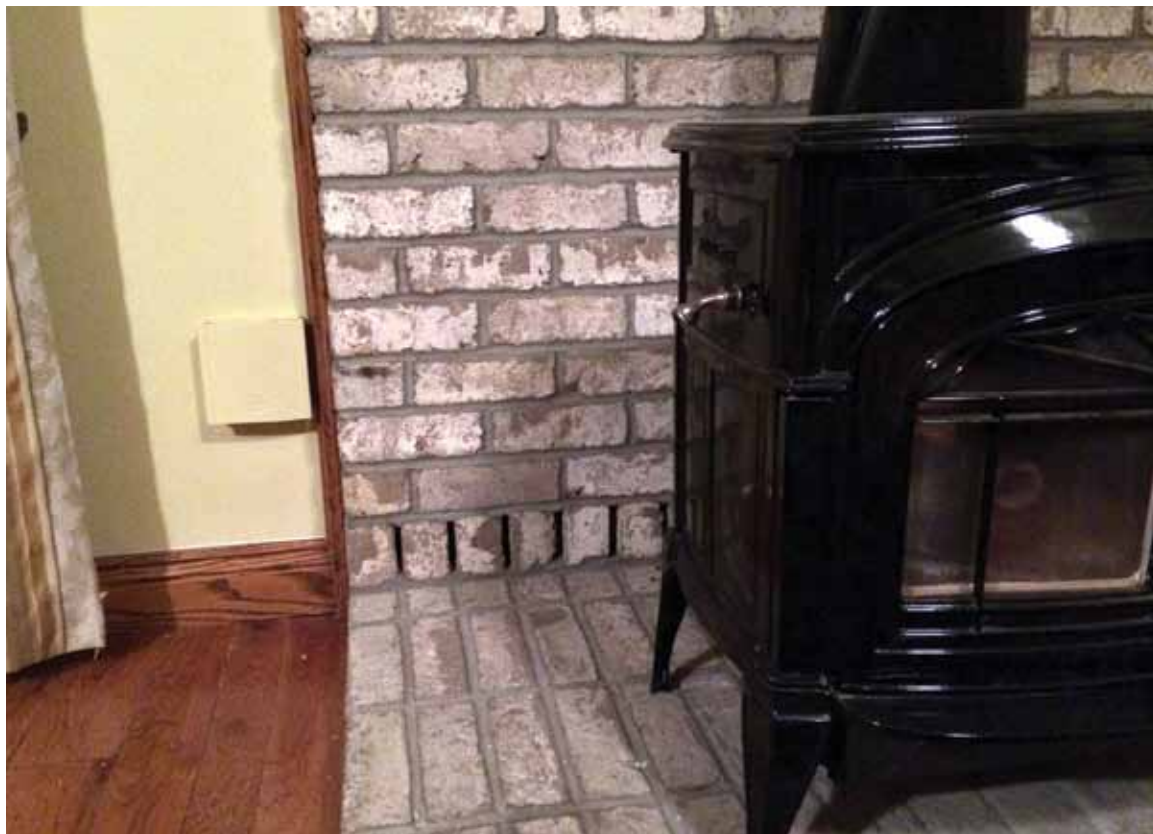
>> A separate fresh-/combustion-air supply was installed near the catalytic wood-burning stove. Its location close to the stove should address cold drafts due to pulling from air infiltration points around the home.

Since we supplement our heat with a catalytic wood-burning stove, a separate fresh-/combustion-air supply was installed near the wood stove. Its location close to the wood stove should address cold drafts due to pulling from air infiltration points around the home.
